2009 Monitoring Summary

Herrin Creek at New Cut Road (Morgan County; 34.378/-87.022)

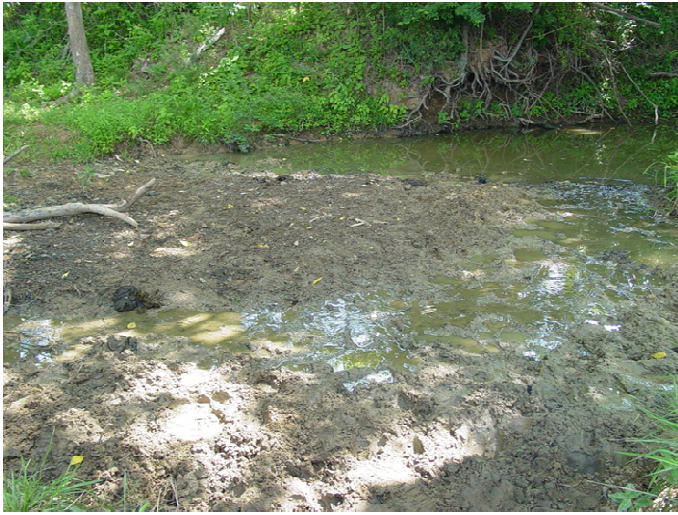
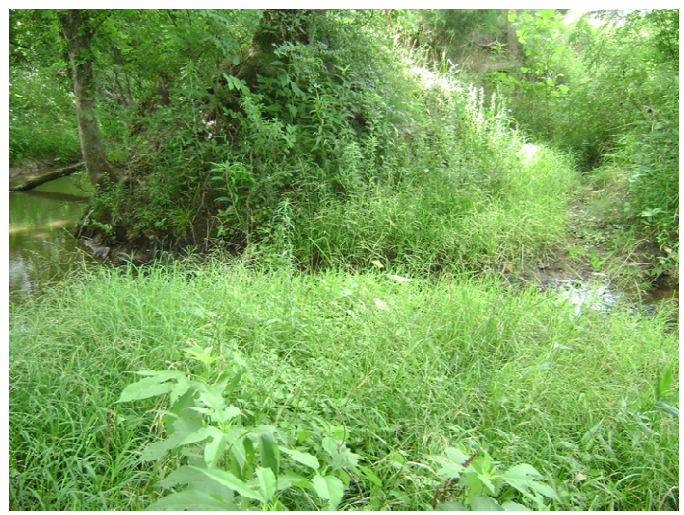
Figure 2a. Site in the Herrin Creek watershed in 2006.

Figure 2b. Same location in 2011 after best management practices were implemented.

Photographs taken in 2006 and 2011 have documented improved conditions throughout the watershed. Although among the most effective BMPs at controlling erosion, forest riparian buffers are also among the slowest to become established and fully effective. The 2009 assessments were conducted only 17 months after the WMP was fully implemented. Additionally, HERM-2, the site closest to the newly forested areas could not be sampled during 2009. HERM-1 is located approximately 2.7 stream miles downstream of the forested buffers. Monitoring and BMP implementation should continue to document trends in habitat, biological and water quality conditions as the riparian forests and other BMPs become more established.

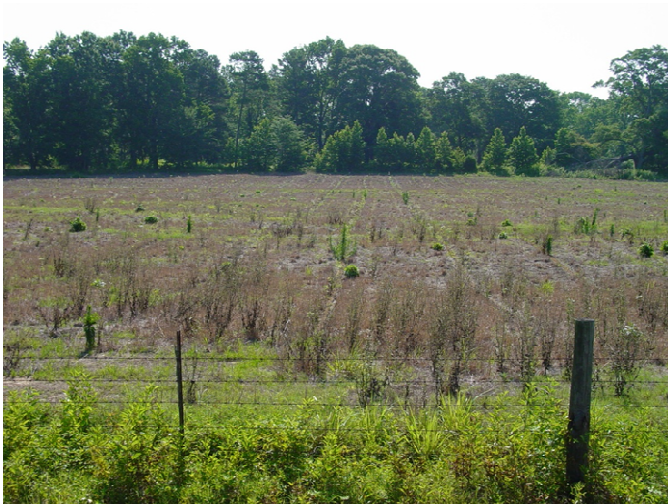
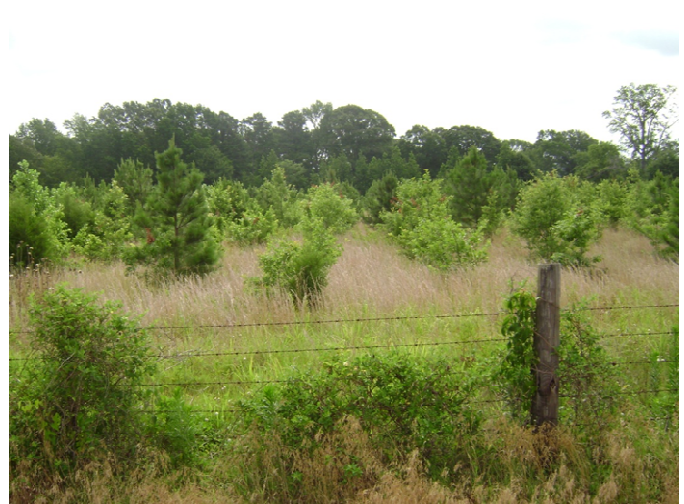
Figure 3a. Site in the Herrin Creek watershed in 2006.

Figure 3b. Same location in 2011 after best management practices were implemented.

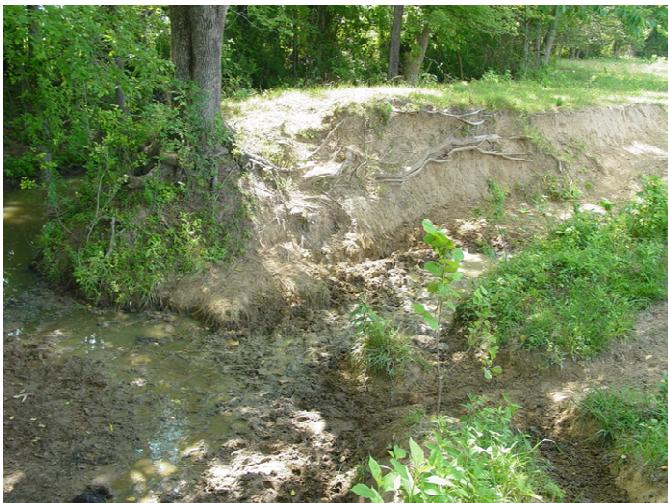
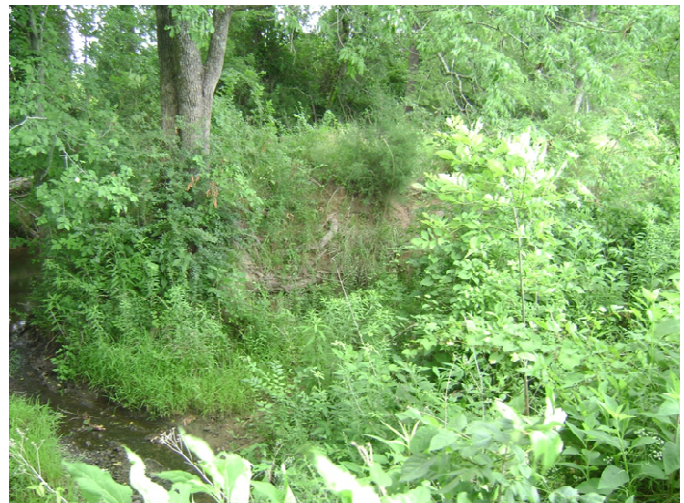
Figure 4a. Site in Herrin Creek watershed in 2006.

Figure 4b. Same location in 2011 after best management practices were implemented.
